PDK Calibration Guide v2.5

For Porsche PDK 911/Boxster/Cayman 997/991/987/981/718

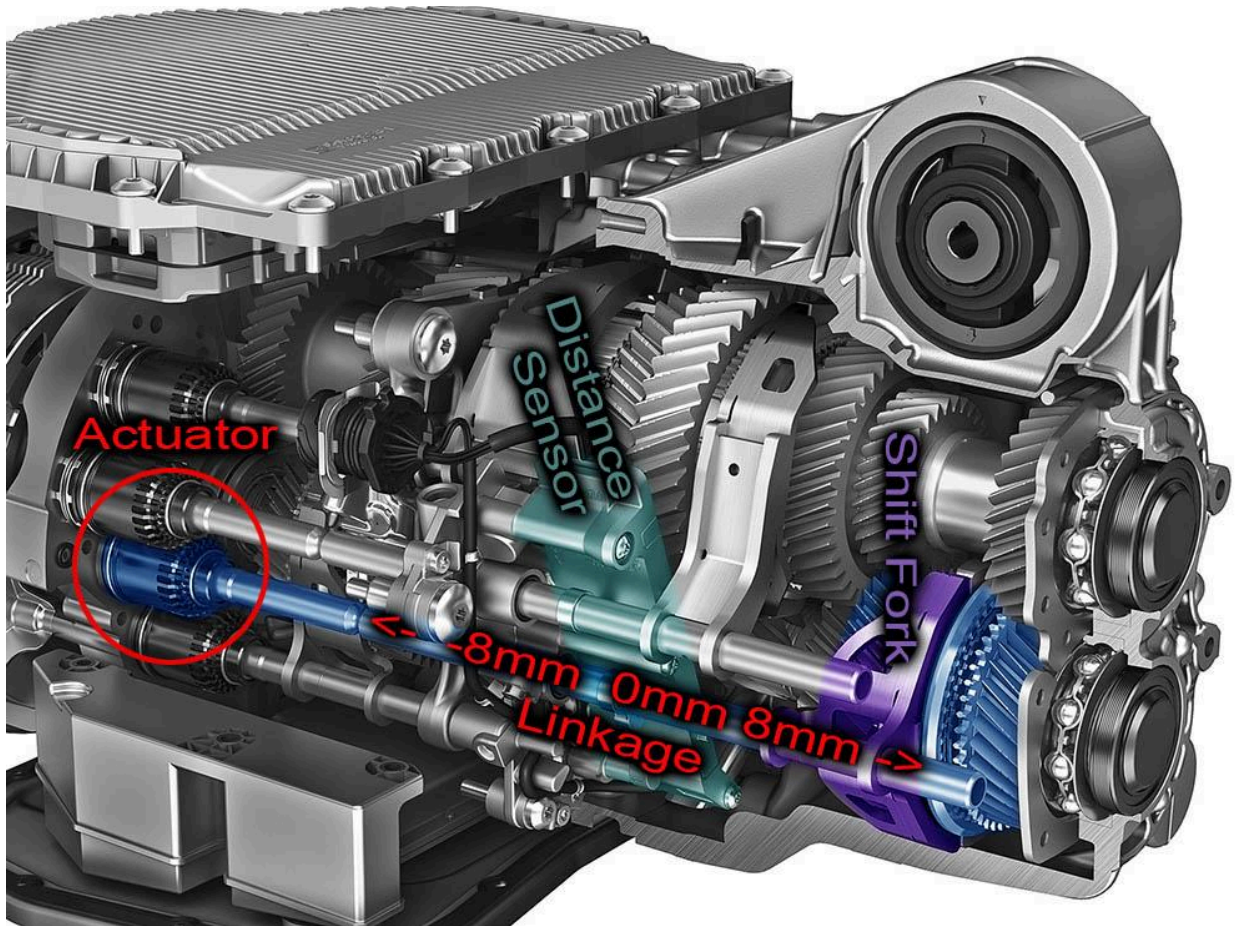
Each “channel” is an assembly of Actuator, Linkage and Shift Fork. Actuators pull/push the Shift Fork. Shift Fork engages one of the two gears on that “channel”. So eight gears in total on four channels. Seven forward gears plus reverse.

The function of the Distance Sensor is to read the position of the Shift Fork and report it to TCU. This way TCU knows what gear is engaged. -8mm indicates one gear on the “channel”, 8mm indicates another gear on the “channel”, and 0mm indicates central position or neutral.

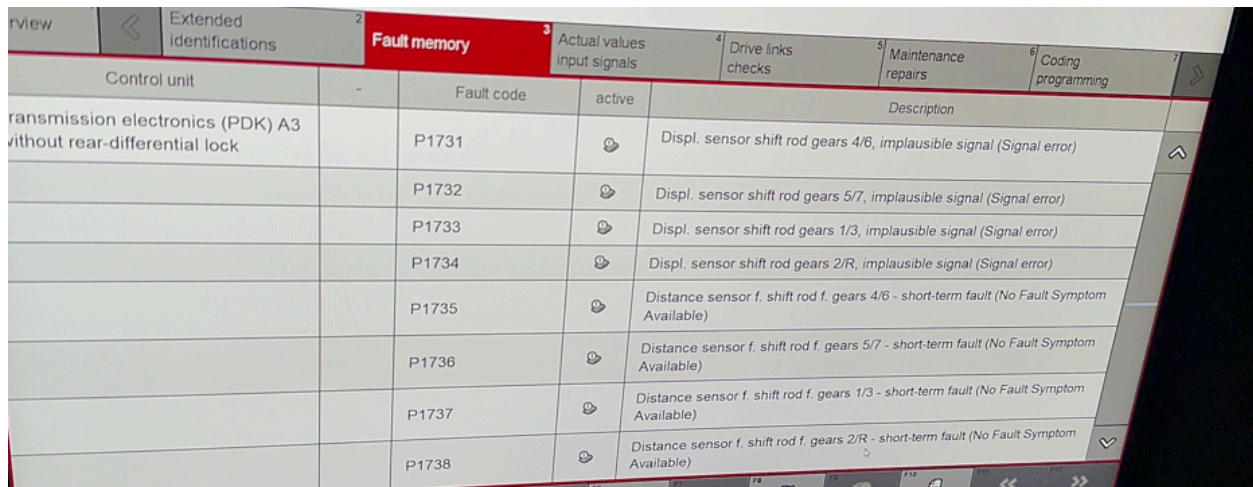
Non-OEM sensors of unknown origin might not follow OEM wiring colors and positions. If an unknown aftermarket sensor was used for splicing reference for installing T-Design sensor - it will produce unpredictable results. Usually errors on all channels like in the picture below:

All our sensors are thoroughly tested at the factory. The only explanation for this full range of sensor errors is that the sensor is not getting the power. Same as not having a Distance Sensor installed at all. This is caused by incorrect wiring.

If after installation you see the screen full of errors like above - trace the wires back from the round plug to the T-Design sensor and check against the pinout below:
